EXECUTIVE SUMMARY AIRCRAFT ACCIDENT INVESTIGATION

F-16CM, T/N 90-0717 AND 90-0733 KUNSAN AIR BASE, REPUBLIC OF KOREA 29 JULY 2011

SUMMARY OF FACTS AND STATEMENT OF OPINION
F-16CM, T/N 90-0717 and 90-0733
29 JULY 2011

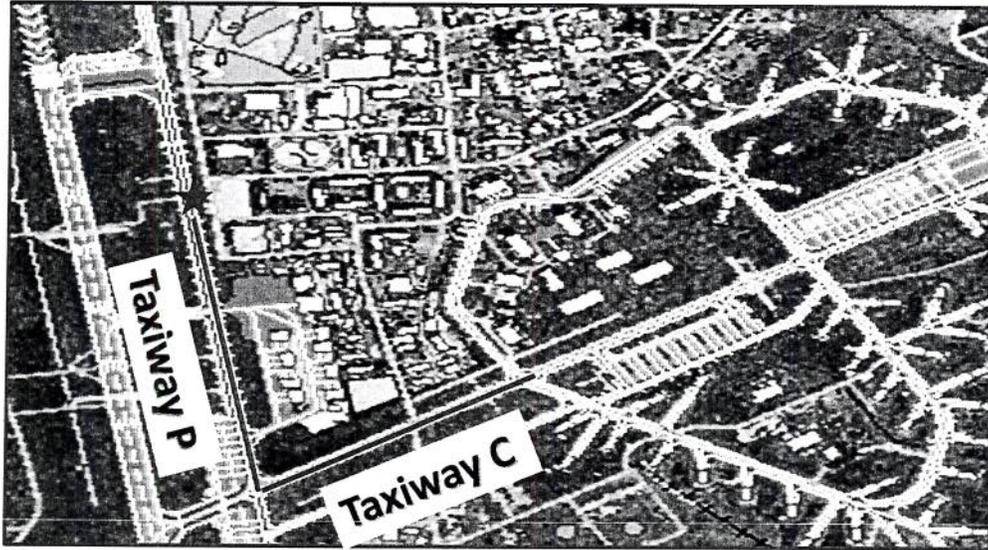
Figure 1. Mishap Flight route of taxi.

The MF began taxiing at approximately 0655L. (Tab V-1.4) The route of taxi was from the south loop, to taxiway C (Charlie), to taxiway P (Papa), to runway 18 (the north end of the airfield, see Figure 1). (Tab R-4) The standard spacing between aircraft while taxiing during the day is 150 feet. (Tab BB-5.2) After the turn from taxiway C to taxiway P, MP1's spacing behind MP2 was between 150 and 200 feet. (Tab V-1.4, R-4) After turning from taxiway C to taxiway P, MP1 stated he resumed his tape title. (Tab V-1.5) As part of the tape title procedure, MP1 compared the target coordinates listed on his mission data card to the coordinates loaded into the aircraft's MMC, which is displayed on a screen just above the pilot's right knee. (Tab V-1.5)

As per the ORE instructions, RWR checks were to be accomplished at the north end of taxiway P while taxiing en route to the runway. (Tab BB-5.2) In accordance with (IAW) local procedures, pilots are to stop for the RWR checks if so signaled by the marshaller. (Tab BB-5.2-5.3) While MP1 was checking his coordinates, he noticed the flight approaching the RWR check area, but stated he felt he had enough time to complete this task prior to reaching the RWR check area. (Tab V-1.6)

MP1 stated he checked the first of four sets of target coordinates, and then looked up to verify his taxi path and spacing. (Tab V-1.6) MP1 stated he then looked down to confirm the remaining three coordinate sets. (Tab V-1.6) He stated he did not re-verify his spacing or taxi path while checking the final three coordinate sets, but examination of the video from his Heads Up Display (HUD) tape shows minor course corrections during this time, with the last noticeable correction occurring 6 seconds prior to impact. (Tab V-1.6) It should be noted the board could not confirm this change in direction was caused by pilot input vice normal drift while taxiing.

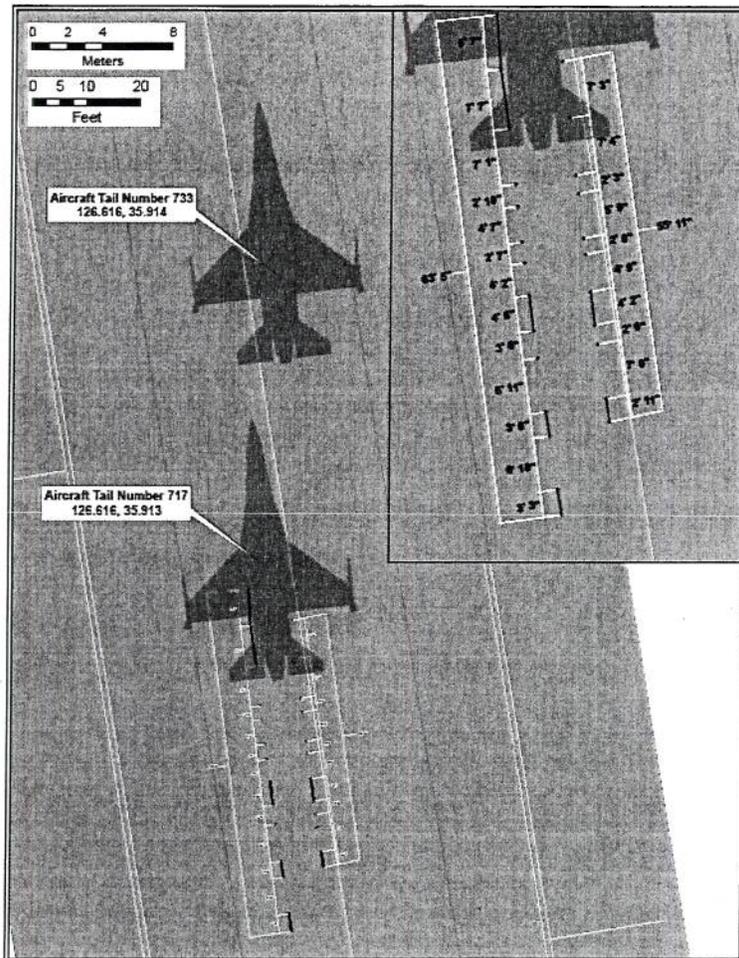
Figure 2. Diagram of aircraft post collision with skid marks.

As the Mishap Flight Lead (MFL) reached the RWR check area, he stopped his taxi to allow the ground crew to complete the check. (Tab R-4) Numbers 2 and 3 of the flight stopped behind the MFL. (Tab R-4) MP1 stated after he finished checking his last coordinate set, he looked up a split second prior to impact. (Tab V-1.6) He immediately applied full brakes while simultaneously impacting MA2. (Tab V-1.6) MA1 impacted the left rear of MA2 at 06:59:20L, causing extensive damage to MA1. (Tabs V-1.6, P-6) MA1 stopped 63 feet from the point of first brake application. (Tab S-3, see Figure 2).

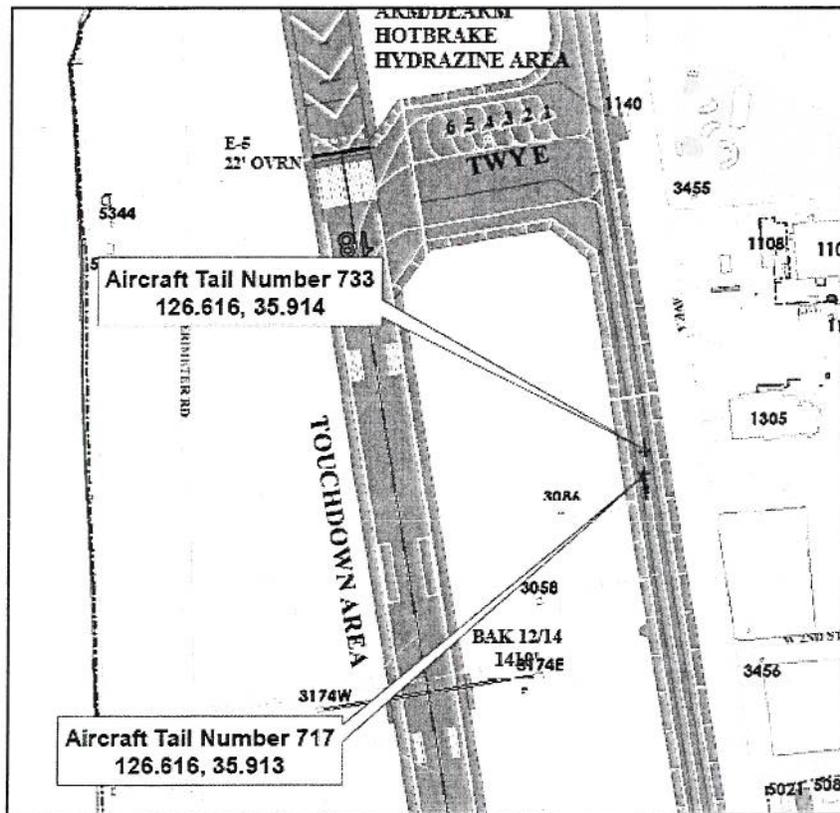
Figure 3. Aircraft position post impact.

The aircraft came to rest approximately 500 feet from the north end of taxiway P at 06:59:25L. (See Figure 3) Both MA1 and MA2 remained on the taxiway after the impact. (Tab S-3)
