UNITED STATES AIR FORCE
AIRCRAFT ACCIDENT INVESTIGATION
BOARD REPORT

F-35A, T/N 19-5535

**355TH FIGHTER SQUADRON
354TH FIGHTER WING
EIELSON AIR FORCE BASE, ALASKA**

DATE OF ACCIDENT: 28 JANUARY 2025

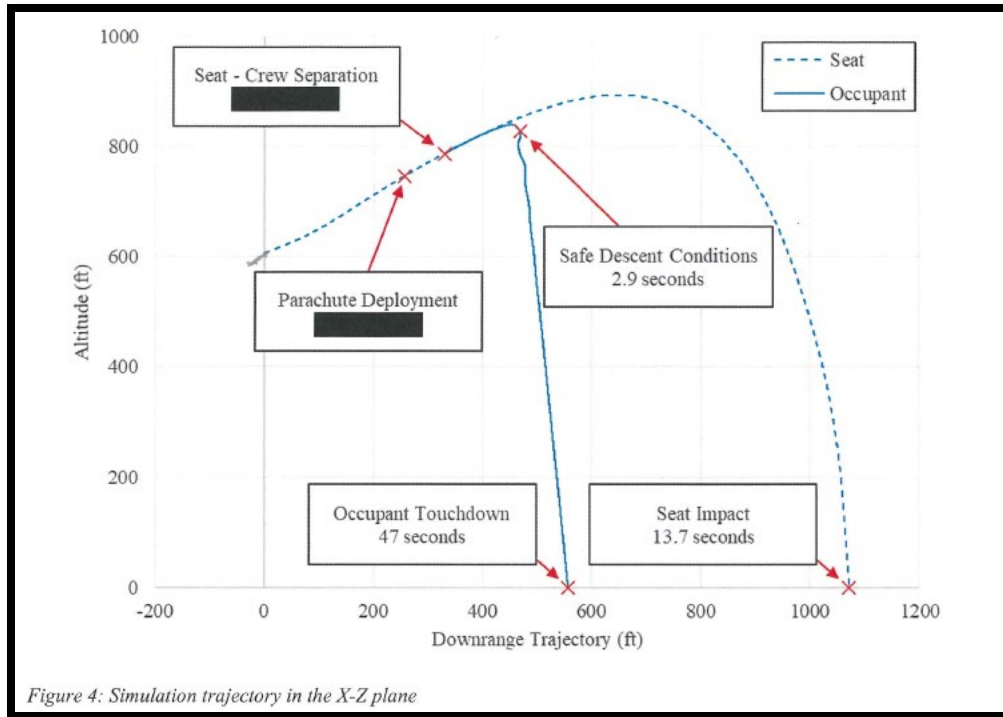
Figure 3: Ejection Seat Trajectory (Tab H-56)

All AFE equipment was current and worked as intended with no issues (Tab H-74). According to the Martin Baker analysis report, the ejection occurred at approximately 620ft AGL at an airspeed of 222 KCAS (Tab H-55). The MA was pitched up 30-40 degrees pitch up and in a 38-degree left bank (Tab H-55).

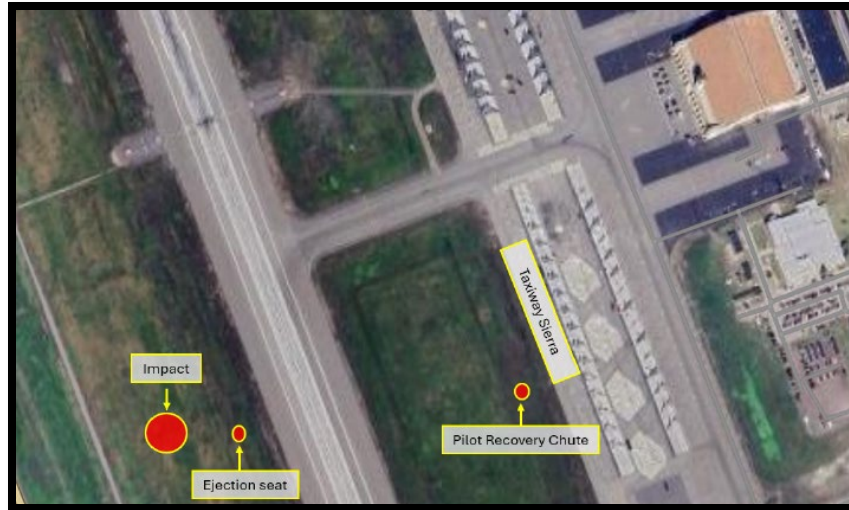
Figure 4: Crash Site Overview (Tab J-102)

At 21:48:44Z, the MP ejected from the MA approximately 10,000ft down the length of Runway 32 (Tab J-102). The MA continued an upward trajectory reaching an altitude of 3,205ft mean sea level (MSL) (2,665 AGL) before stalling and descending in an uncontrolled state, impacting the ground in a 116-degree right bank at 21:49:16 (Tab J-102). First responders were on scene within one minute (Tab V-1.4).

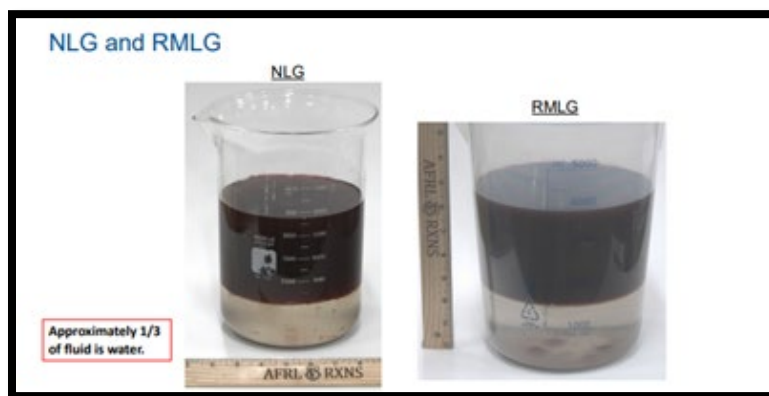
Following the mishap, the Air Force Research Laboratory (AFRL) tested the hydraulic fluid in the MA's NLG and RMLG (Tab J-19). AFRL found that approximately one-third of the fluid retrieved from the RMLG and NLG was water (Tab J-19).

Figure 5: NLG and RMLG Hydraulic Fluid Contamination (Tab J-190)

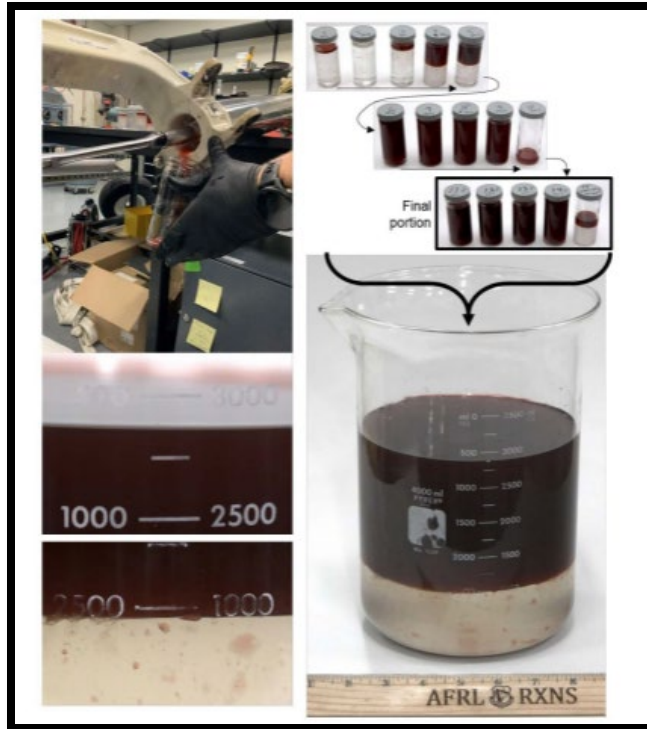
Figure 6: 1L of Water Found in 2.8L of NLG Hydraulic Fluid (Tab J-190)

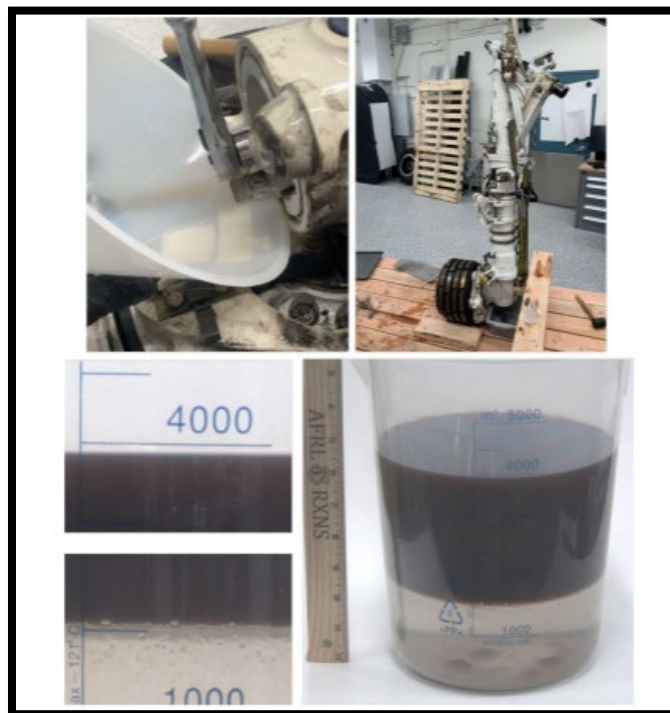
Figure 7: 1.5L of Water Found in 4L of MLG Hydraulic Fluid (Tab J-28)

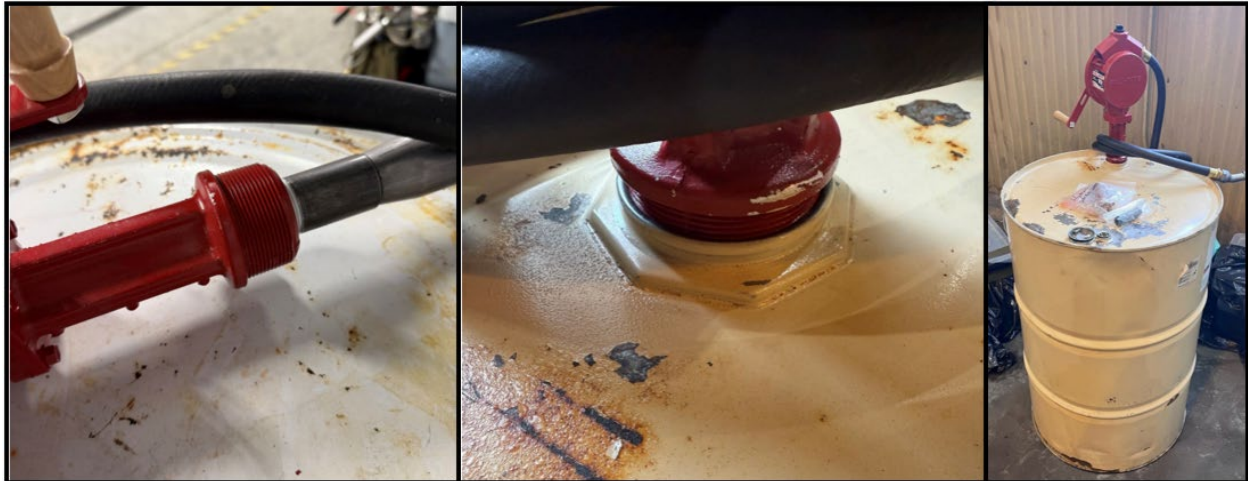
Additionally, HACOM program managers did not lock the barrels, observe servicing of hydraulic cart to ensure maintainers were properly servicing hydraulic or oil hand carts, nor log what hydraulic or oil servicing carts were filled from the barrels (Tab V-10.3, 10.4). Moreover, the hydraulic pump that sits on top of the barrel had no Teflon thread sealer, which could permit water to contaminate the hydraulic fluid if the barrel was not stored properly (Tab Z-3, 4, 12).

Figure 9: Contaminated Hydraulic Barrel and Pump Threads (Tab Z-3, 4, 12)

The Airmen in the 355th FGS HAZMAT program did not follow established procedures and technical orders for storing and handling hazardous materials. Specifically, they stored hydraulic barrels outside while deployed to Kadena AB, Japan, and on at least one other temporary duty away from Eielson AFB. At both locations the barrels were exposed to humid conditions and inclement weather. Further, at home station 355 FGS personnel did not observe personnel while they were filling hydraulic carts for use, lock the hydraulic barrel when not servicing carts, document when and how much hydraulic fluid was used, nor appropriately dispose of a barrel certified as empty. Because of poor record keeping, it is unclear whether the barrel certified for disposal was the same barrel that was stored outside and exposed to inclement weather. But the barrel used to service the mishap aircraft was contaminated with significant amounts of water.

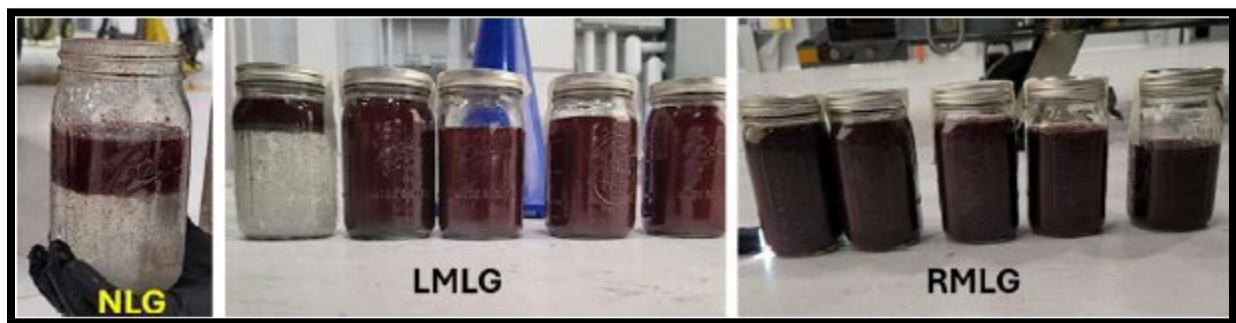
A post flight test was done on this aircraft by first towing it into a climate-controlled shelter (approximately 70 degrees F) and recording the nitrogen pressures on the landing gear shock struts (Tab J-195). The aircraft was then towed outside where temperatures remained below 15 degrees Fahrenheit (F) (Tab J-195). After 12 hours outside, the aircraft was jacked up until all landing gear cleared the ground (Tab J-195). Measurements were then taken of the landing gear struts (Tab J-195). The aircraft's Landing Gear failed to reach full extension (Tab J-195). When the MLG struts fail to fully extend, the WoW switches cannot physically extend and do not function properly (Tab J-118). Temperature was taken of all three struts which measured 14F for the NLG, and 7F for the LMLG and RMLG. The aircraft was then lowered and towed back into a 70F climate-controlled hanger and sat for 12 hours (Tab J-195). All three landing gear struts were then drained of all fluid into mason jars (Tab J-195). The NLG and LMLG had a significant amount of water present while the RMLG appeared to be all hydraulic fluid (Tab J-194-95).

Figure 9: Contaminated NLG and LMLG Hydraulic Fluid (Tab J-195)

This subsequent incident and test replicate the same conditions that the MA was experiencing (Tab J-194). The presence of water in the LG struts during below freezing weather conditions did not allow the gear to fully extend in either aircraft (Tab J-195-96).

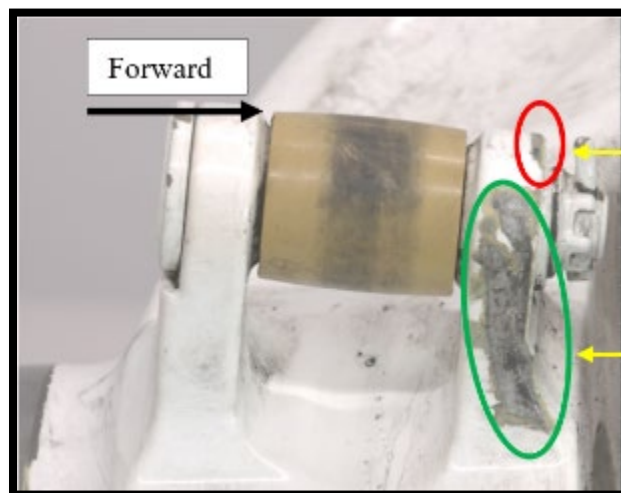
At the beginning of the mishap flight, the NLG didn't fully extend due to ice build-up within the NLG strut (Tab J-189). This ice buildup was the combination of significant water contamination in hydraulic fluid used to service the struts and ambient freezing temperatures around Eielson AFB (Tab J-189). The lack of full extension caused a misalignment that prevented the NLG uplock hook from catching the NLG uplock roller, causing damage to the metal adjacent to the roller (Tab J-185).

Figure 12: Damaged NLG Uplock Hook (Tab J-185)

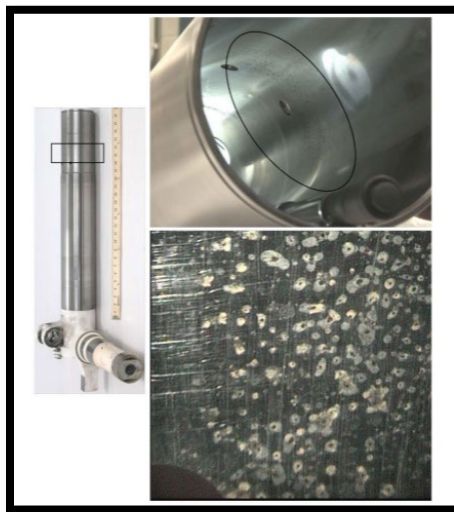
Additionally, significant pitting was identified within the LG piston that, while caused by contamination to the hydraulic fluid, did not affect the LG function (Tab BB-255).

Figure 14: Pitting Identified in MLG Piston (Tab J-29)
