**UNITED STATES AIR FORCE
AIRCRAFT ACCIDENT INVESTIGATION
BOARD REPORT**

F-16CM, T/N 90-0771

**36TH FIGHTER SQUADRON
51ST FIGHTER WING
OSAN AIR BASE, REPUBLIC OF KOREA**

**LOCATION: HWACHON-RI, HWAYANG-MYEON, SEOICHEON,
CHUNGCHEONGNAM, REPUBLIC OF KOREA
DATE OF ACCIDENT: 21 MARCH 2012
BOARD PRESIDENT: LIEUTENANT COLONEL WILLIAM R. JONES**

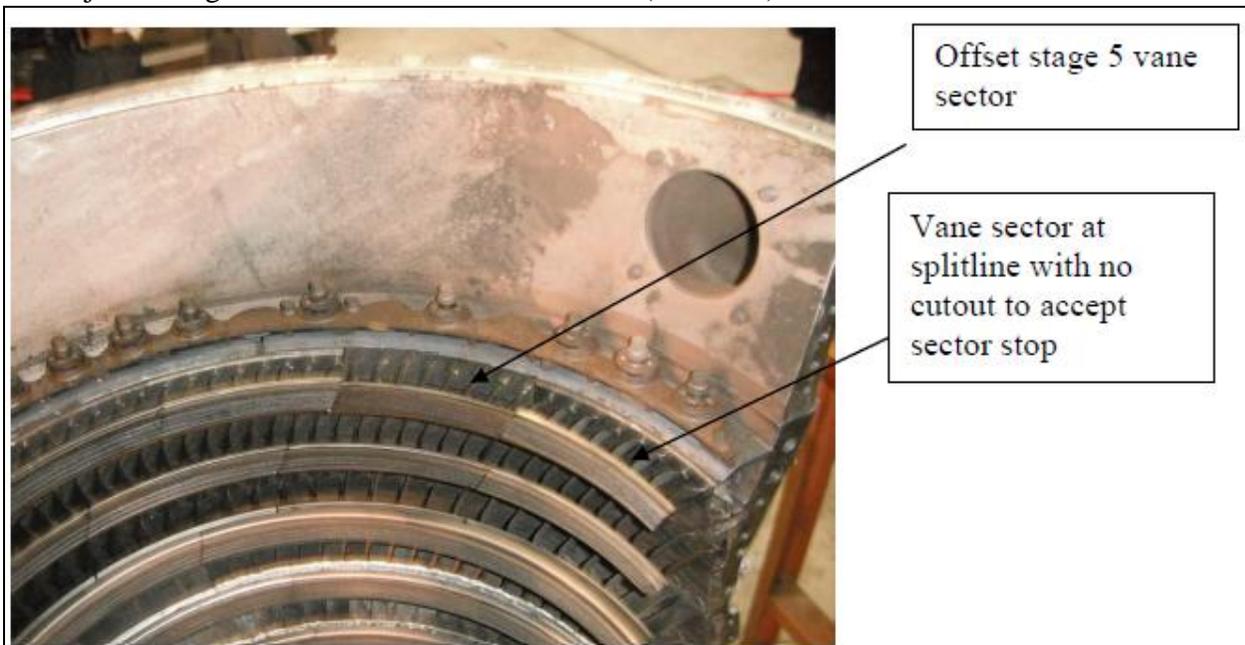
The lower and upper outer fan ducts were moderately damaged with buckling and holes due to the impact (Tab J-23). The exterior of the forward stator case assembly exhibited no signs of damage (Tab J-24). Stage 1 vane sectors had damage to the leading edge on several vanes with no trailing edge damage (Tab J-24). Stage 2 sector vanes had minor nicks on both the leading and trailing edges (Tab J-24). Stage three vanes showed heavy damage on the leading edges and minor damage on the trailing edges (Tab J-25). Stage 4 vane sectors exhibited much more damage on the trailing edges than the damage noted on the stages forward of stage 4 (Tab J-25). Uniform damage was identified in the form of large tears and nicks along the outer diameter of the stage 4 vane sectors (Tab J-25). One of the stage 5 vane sectors was found offset from the two adjacent stage 5 vane sectors as shown below (Tab J-25).

Forward case with two incorrectly installed stator vane sectors (Tab J-25)

The offset stage 5 vane sector was turned 180 degrees in the radial direction, that is to say it was found installed 180 degrees out from its designed position. The offset sector has a cutout to accept the anti-rotation stop whereas the vane sector installed at the 3 o'clock splitline did not have a cutout for this stop (Tab J-25). This indicates that not only was the vane sector installed 180 degrees out but the positions of these two stator vane sectors were incorrect.

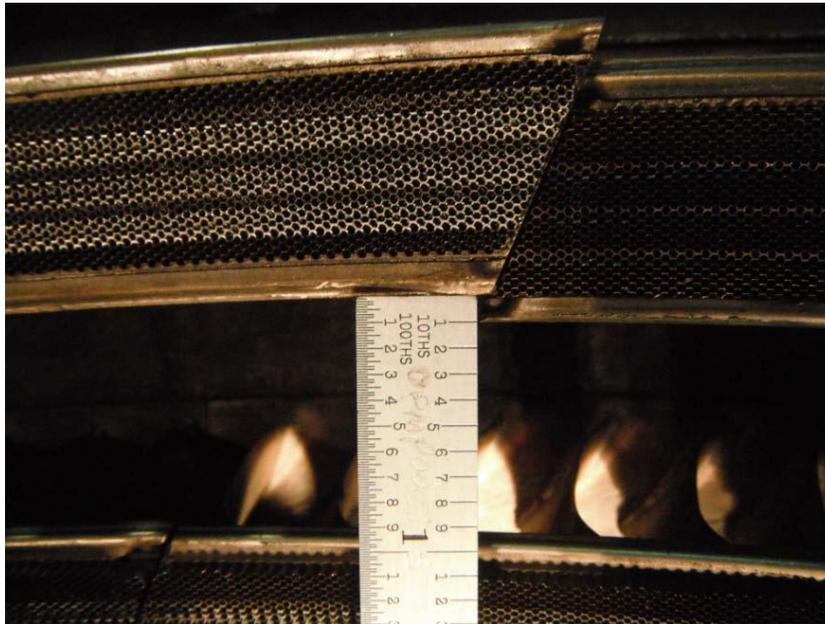
The incorrectly installed sector extended forward approximately 0.1 inch into the stage 5 compressor blade area as shown below (Tab J-25).

Offset vane sector extending forward 0.1 inch (Tab J-26)

All stage 5 vanes showed significant damage on both the leading and trailing edges (Tab J-26).

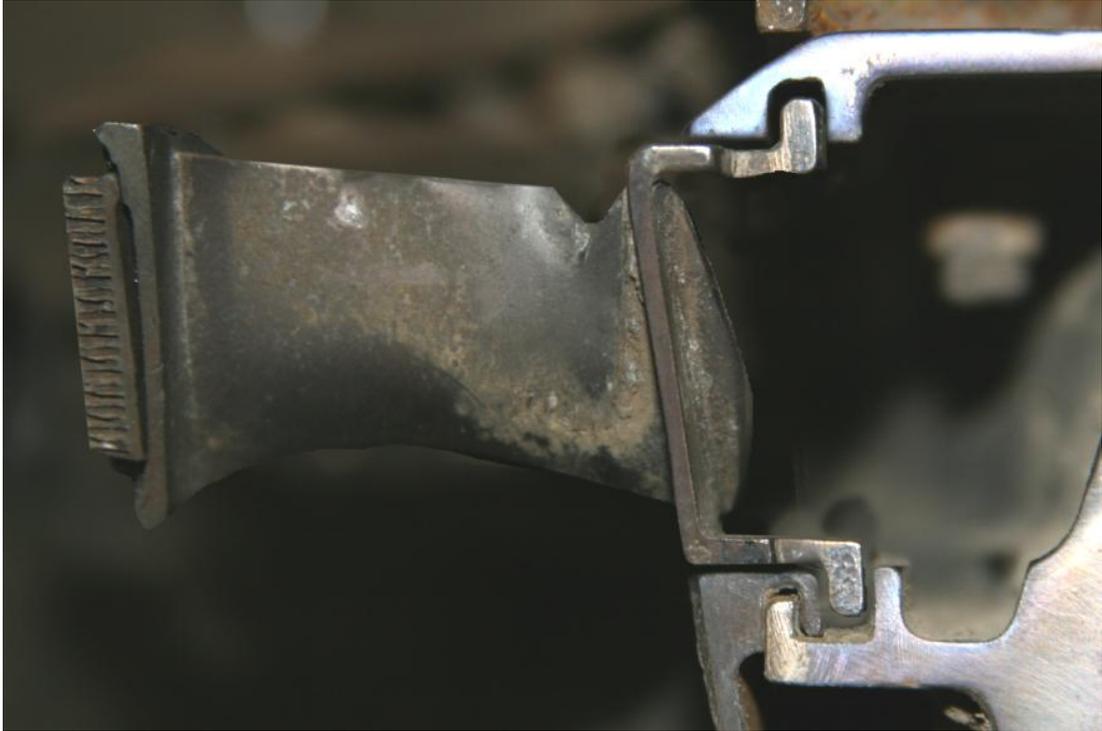
Correctly Installed Stator Vane Sector

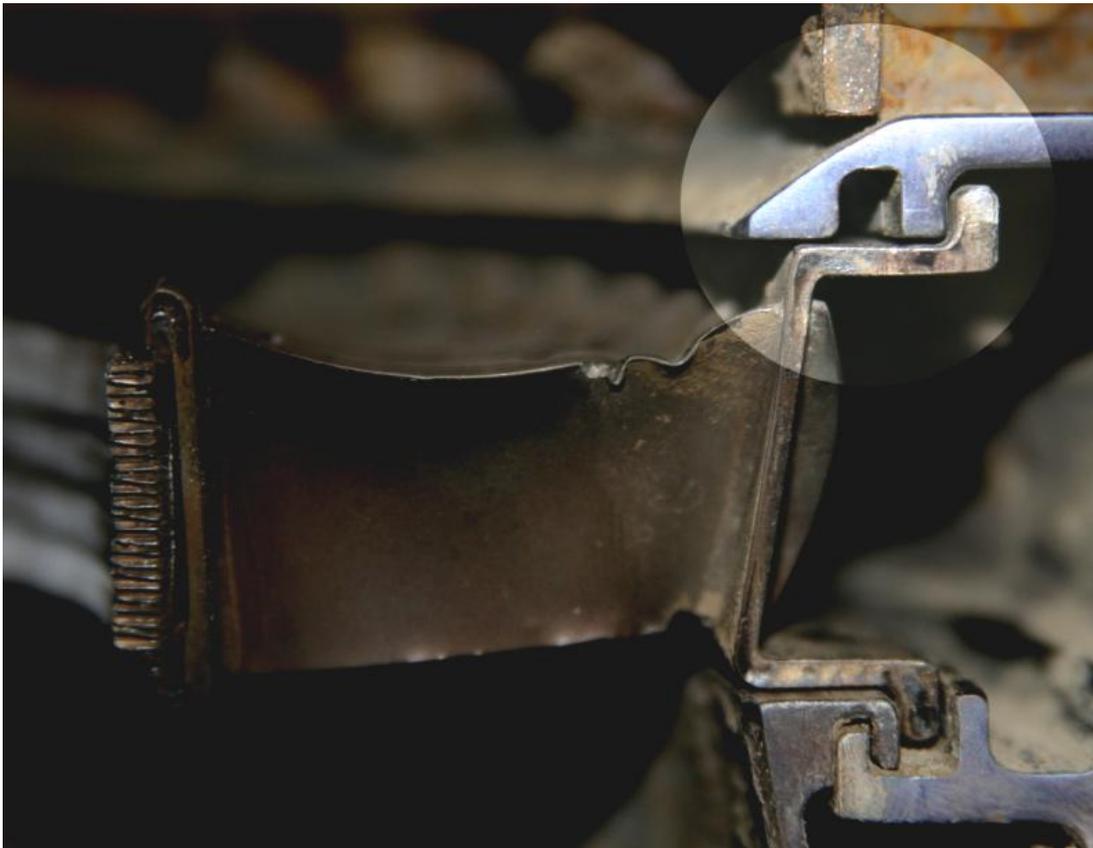
The aft compressor case showed severe damage on both leading and trailing edges (Tab J-26). For the compressor rotor, stages 1-4 were all intact with damage on the leading and trailing edges (Tab J-26). Stage 5 blades of the compressor rotor showed extreme damage and four stage 5 blades were liberated (Tab J-26). Metallurgical examination revealed that all four blades fractured in fatigue with features consistent with low-alternating stress, high-cycle fatigue (Tab J-46). Of the four liberated blades, two were liberated based on the vibrat~~ion~~pp-induced loading while the other two were liberated based on the subsequent stall (Tab J-46). The first two blades to liberate were shown to have a crack initiating from a small impact at the leading and trailing edges (Tab J-46). This is consistent with the bead damage that the ME was originally removed for and routed to JEIM for repair (Tab U-51). Inconsistent pressure within the compressor section resulting in pressure pulsing would be one of the effects of an improperly installed stator vane sector in stage 5 (Tab U-153).

Incorrectly Installed Stator Vane Sector

From 24 February 2011 through 27 June 2011, the ME was disassembled. Many of the repairs included repairing or replacing compressor blades and stator vanes sectors. During this period, stage 5 stator vane sectors E and F either were removed or fell out of the upper forward compressor casing. Both vane sectors were incorrectly installed in reverse order. More critically however, stator vane sector F was installed backwards; that is to say, it was rotated 180 degrees out of the normal position.

I find by clear and convincing evidence that the primary cause of the accident was an incorrectly installed stage 5 stator blade sector, brought about by an inadvertent operation and procedural error, which occurred during maintenance on the Mishap Engine. I further find by a preponderance of evidence that procedural guidance substantially contributed to the mishap by failing to instruct maintenance members with suitable detail in the manner in which the error could occur as well as failing to represent the magnitude of the risk associated with the error.
