**UNITED STATES AIR FORCE**  
**GROUND ACCIDENT INVESTIGATION**  
**BOARD REPORT**

**TYPE OF ACCIDENT: On-Duty Fatality**

**LOCATION: Joint Base Pearl Harbor-Hickam, Hawaii**

**DATE OF ACCIDENT: 8 January 2013**

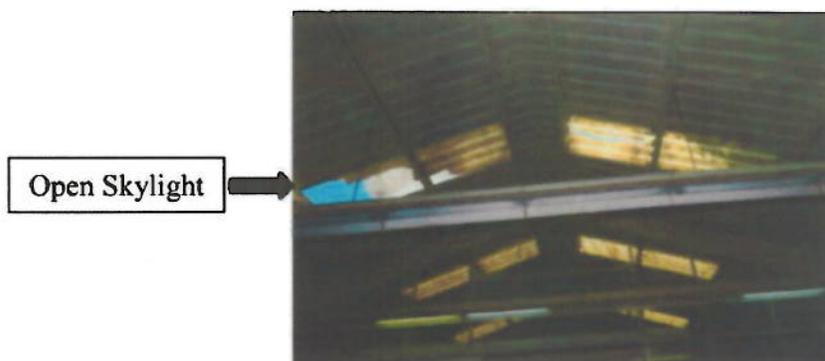
Figure 1 (Tab Y-24)

1400H – 1430H: MS walked MA through the anticipated project and showed MA the open skylight from the interior of the building (Tab V-3.26, Fig. 1). MS stated that he specifically

warned MA to be wary of the “brittle” skylights, and told him not to come onto the roof until “the last minute” for safety purposes (Tab V-3.27).

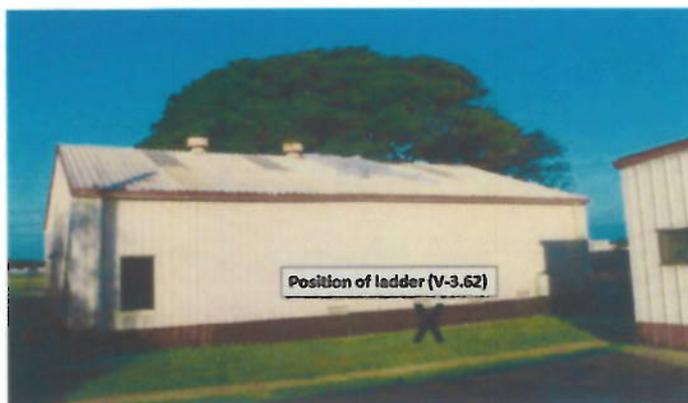
Figure 2 (Tab Y-17)

1430H – 1445H: MS and MA erected an A-Frame ladder to access the roof. The ladder was positioned directly below the open skylight immediately next to the outside East wall of the building (V-3.29, Tab V-3.62, Tab V-15.1, Tab V-15.5, Fig. 2). MS and MA staged the plastic sheeting and sandbags at the base of the ladder (Tab V-3.28 to V-3.30, Tab V-3.61). MA remained on the ground and handed the equipment to MS to carry up the ladder and onto the roof (Tab V-3.30). MS staged the equipment on the roof (Tab V-3.29 to V-3.31).

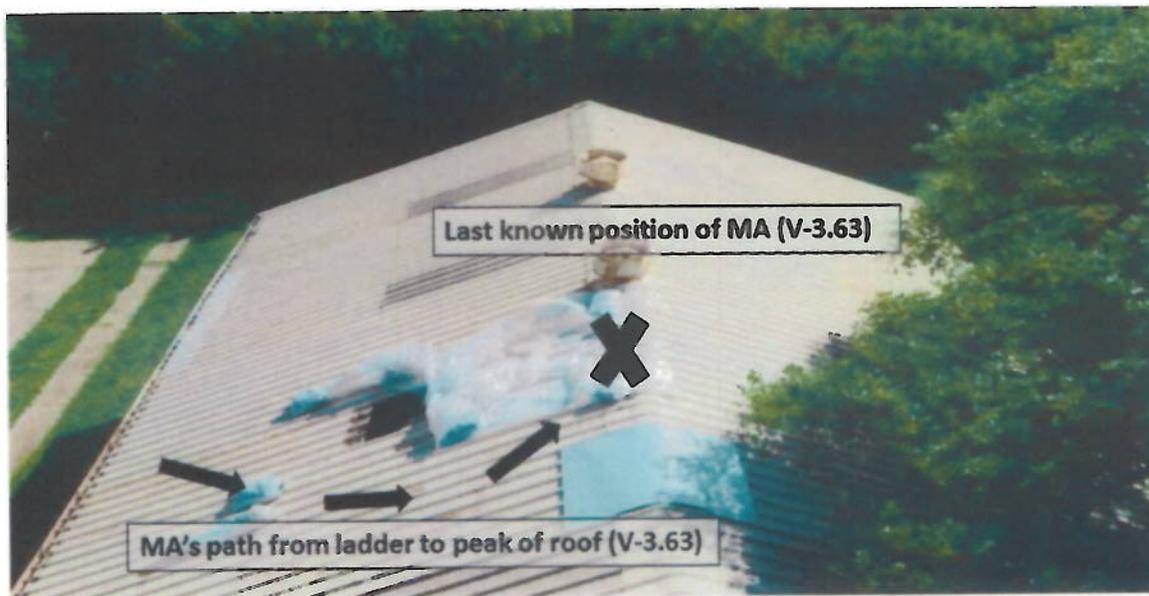
Figure 3 (Tab Y-8)

1445H – 1455H: MS stretched out pre-cut plastic sheeting and directed MA to join him on the roof to help place the plastic sheeting under the sandbags (Tab V-3.31). MA climbed up the ladder and walked to the roof peak above the damaged skylight (Tab V-3.31 to V-3.32, Tab V-3.63, Fig. 3). From this position, MS estimated that MA was likely standing on the 2 foot, 9 inch wide portion of roof between the open skylight being covered and the intact skylight directly behind him (Tab V-3.36, Tab V-3.63, Tab Y-5, Fig. 3). MA and MS secured the plastic sheeting beneath the sandbags (Tab V-3.33). MS determined the plastic sheeting needed trimming (Tab V-3.33). MS began to descend the ladder to retrieve a knife from their truck to cut the plastic. As MS looked away, MA was on the ridge continuing to work with the plastic sheeting (Tab V-3.34). MS stated “I don’t know if he was straightening it out or like trying to push it out, but he was doing something with it” (Tab V-3.34). MS could not recall whether MA was kneeling or crouching (Tab V-3.34) or if MA was wearing a hard hat while on the roof (Tab V-3.42 to V-3.43). Approximately five seconds after looking away from MA, as MS began to descend the ladder, he heard a crack followed by a scream (Tab V-3.37 to V-3.38). MS looked up, did not see MA on the roof, and rushed down the ladder (Tab V-3.37). MS ran inside the building and found MA on the floor, lying on his back (Tab V-3.38). MA was lying underneath the skylight that was directly behind him when he worked on the plastic sheeting (Tab V-3.43, Tab V-3.64). The skylight above him, previously undamaged, was cracked (Tab V-3.49 to V-3.50).

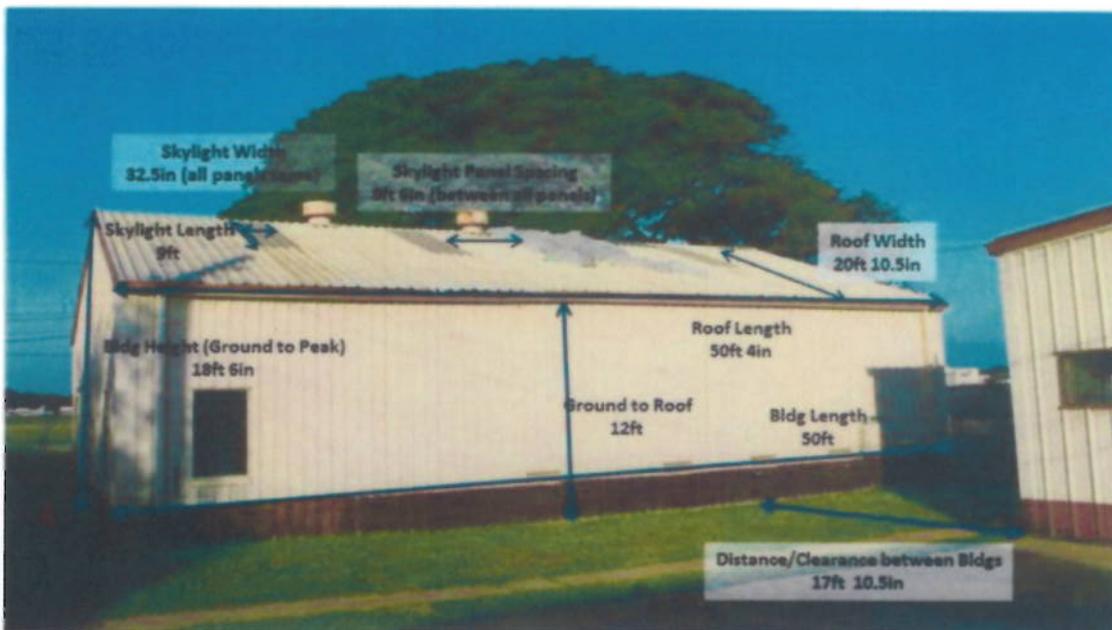
Figure 6 (Tab Y-4)

(1) Failure to utilize fall protection systems. The roof of building 3245 is 12 feet above the ground at its lowest point and 18ft 6in above the ground at the peak (Tab Y-4). Both relevant safety regulations, AFI 91-203 para. 13.2 and Department of the Navy Fall Protection Guide for Ashore Facilities, 20 May 2003, para. 1.5, as referred to in OPNAV Instruction 5100.23, Chapter 13, direct the use of fall protection equipment when performing construction work six feet or higher above the ground. MS and MA failed to utilize any form of fall protection equipment while performing repairs to building 3245, which was not in compliance with either Air Force or Navy regulations (Tab AA-3.3 to AA-3.12, Tab AA-7.2, Tab AA-8.4).

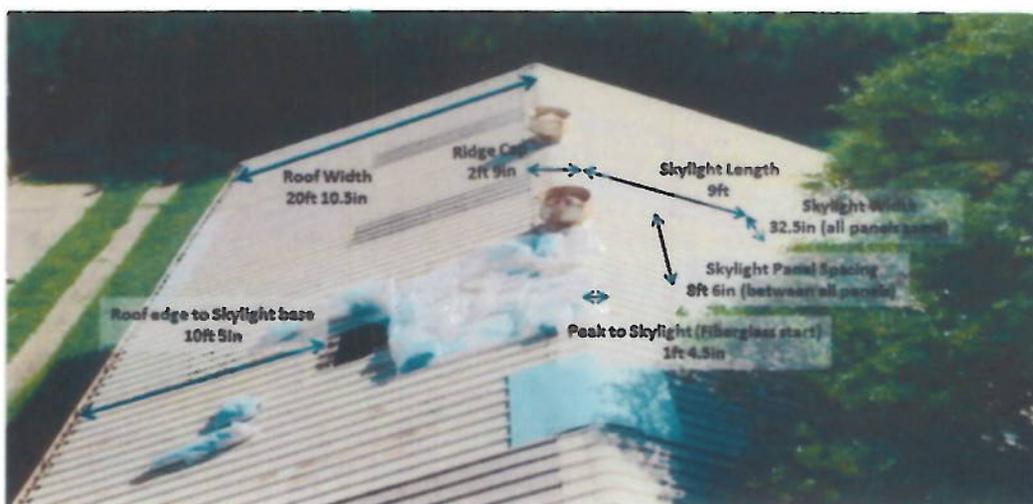
Figure 8 (Tab Y-5)

(3) The roof construction consists of ribbed metal roof sheeting and a metal ridge cap approximately 2ft 9in wide (Tab BB-5.1, Tab Y-5, Fig. 8). There are eight ribbed fiberglass skylight panels, four on each side of the roof (Tab BB-5.1, Tab Y-5, Fig.8). The panels are spaced 8ft 6in apart from each other and are inlayed in the roof (Tab BB-5.1, Tab Y-5, Fig.8). The exposed portion of the fiberglass skylight panels are 32.5in wide by 9ft long with the starting point beginning at the edge of the building ridge cap (Tab BB-5.1, Tab Y-5, Fig. 8). The fiberglass skylight panels appear thin and brittle (Tab Y-12).

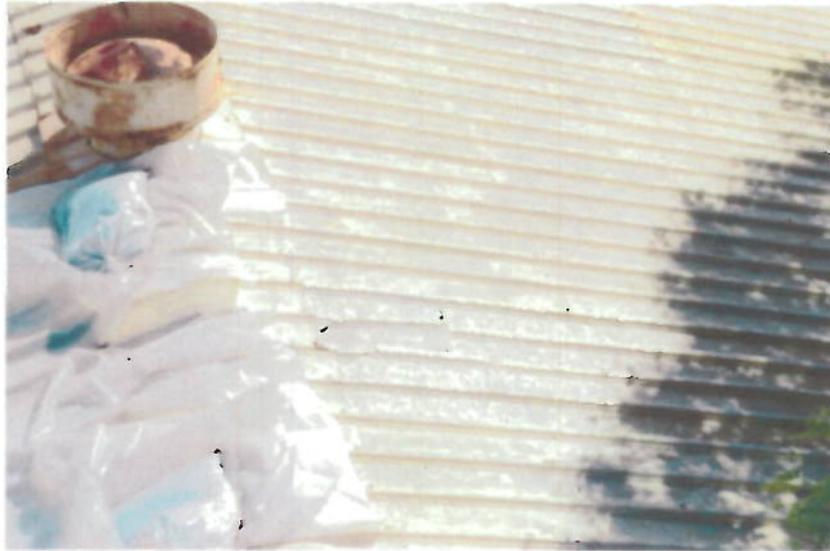
Figure 9 (Tab Y-9)

(4) The fiberglass skylight panels are easily visible from inside building 3245 during daylight hours (Tab Y-23). From above the building, the skylights appear similar in color and texture to the building roof (Tab Y-9, Fig. 9).
