UNITED STATES AIR FORCE
AIRCRAFT ACCIDENT INVESTIGATION
BOARD REPORT

HH-60G T/N 91-26354

**33RD RESCUE SQUADRON
18TH WING
KADENA AIR BASE, JAPAN**

DATE OF ACCIDENT: 5 AUGUST 2013

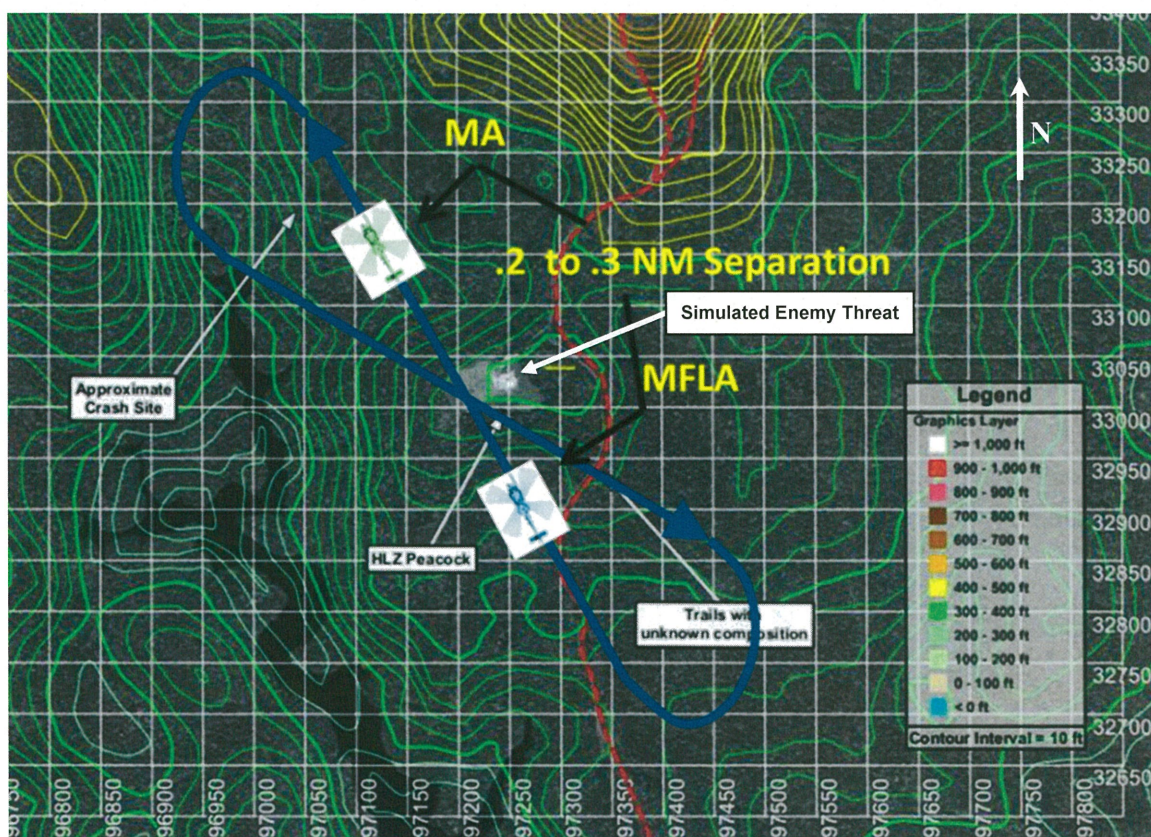
Figure 1. Desired Turn Reversal Racetrack (Tab Z-3)

MFLP's game plan, upon arrival at the IP, was to fly a racetrack pattern between the SDH and any potential threat (Tab V-1.9, V-2.12 and V-4.10 to V-4.12) (see Figure 1). Upon arriving at the terminal area and before dropping off the CRO and PJs near the SDH survivor, MF entered into a northwest-southeast oriented gun-pattern racetrack initially planned for 300 feet above ground level (AGL) with MFLA in the formation lead position (Tab V-2.12, V-4.12 to 4.15, V-4.30 and V-4.39).

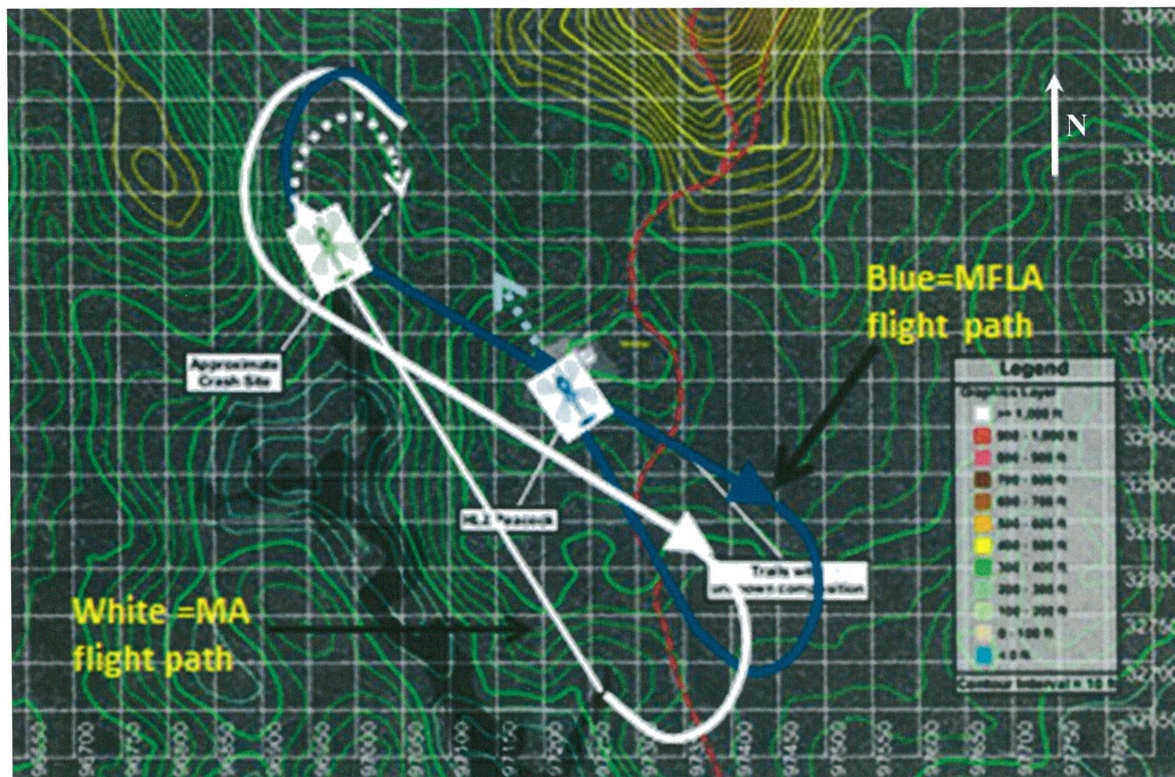
**Figure 2. Mishap Aircraft and Mishap Flight Lead Aircraft
Separate Ground Track (Tab Z-5)**

MA to correct their pattern by shifting back to the east, to once again place MA between friendly forces and the last known threat area (Tab V-4.15 to V-4.16 and V-6.3 to V-6.4). The pattern shift was acknowledged by the MC (Tab V-4.19 to V-4.21). At the same time, MFLA continued to follow the ground track between survivor and anticipated threat, thus placing it east of MA (Tab V-4.15, V-4.30 and V-5.17 to V-5.18). After the MF turned right to a northeast heading, MFLP noted that MA was still west of desired ground track and MFLP again directed a pattern correction to the east, which again the MC acknowledged (Tab V-4.15 to V-4.16). During all racetracks, the MFLA, flying in the trailing formation position, maintained the desired ground track, which was between the SDH survivor and simulated threat and to the east of the MA ground track on the last racetrack. In order for MFLA to maintain the desired ground track, they had to fly at the seven o'clock position of MA when flying southeast and at the five o'clock position when flying northwest, while maintaining .2 to .3 NMs separation (Tab V-1.32, V-2.34, V-4.15 to V-4.16 and V-4.31). Flying within the 5 o'clock to 7 o'clock position is where MP and MCP stated they would have expected the trailing aircraft to be (Tab V-1.32 and V-2.34).

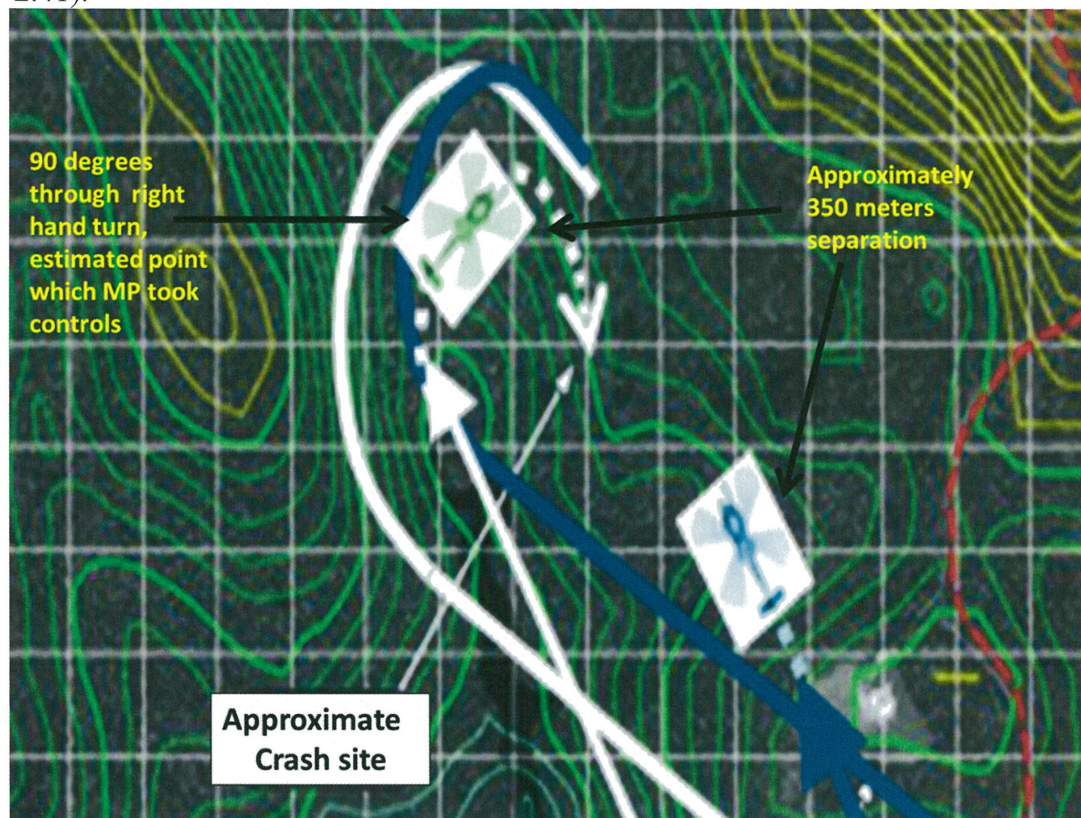
Figure 3. Mishap Pilot's Perceived Conflict Approximate Location (Tab Z-7)

It is at this point, approximately 90 degrees through the maximum performance (turning as fast as possible with the smallest radius possible for a specified airspeed) right turn, MP saw MFLA through the green house window (the window in the ceiling), which was not where MP expected to see MFLA (Tab V-1.14, V-1.30 and V-1.32 to V-1.33) (See Figure 3). MP perceived that MFLA was closing on the MA and there was danger of a midair collision (Tab V-1.14 and V-1.30). However, MFLP, MFLCP, and MFLFE indicated otherwise (Tab V-1.14, V-1.30, V-4.34, V-5.18, V-6.4 and V-7.4). While MFLP acknowledged that had he done nothing with MFLA there would have been a conflict, which is normal for this type of pattern, MFLP negated this conflict by turning to the left, with subsequent intent to follow MA in the right turn (Tab V-4.32). Further MFLP, MFLCP and MFLFE reported no sense of urgency and stated that MA and MFLA remained .2 to .3 NM distance apart (Tab V-4.34, V-5.18 and V-6.4). In addition, the MP stated the MFLA was approximately 1,000 feet at the time he first saw the MFLA (Tab V-1.33).

As a result of his perception, MP took the flight controls from MCP and increased the angle of bank from the 40-50° to an unspecified steeper angle. MP also decreased the collective (the collective changes pitch of the main rotor blades causing an increase or decrease in lift) by approximately 3-4 inches (Tabs V-1.14, V-1.16 to V-1.17, V-1.35, V-2.14 and BB-14). MP's intent was to avoid MFLA's flight path by tightening MA's turn in order to break phase and plane (turn through MFLA's flight path in a descending turn) and reversing the turn to continue around until MA would eventually rejoin behind MFLA in the gun pattern (Tab V-1.15, V-1.30 and V-1.35). While every aircraft ultimately has a responsibility for collision avoidance, in HH-60G gun patterns, the formation lead aircraft is responsible for ground track while the wingman is primarily responsible for spacing and collision avoidance (Tab BB-7). Although MP intended to descend during this maneuver, upon rolling out, MA was lower than MP anticipated (Tab V-1.15, V-1.30 and V-1.38). Realizing MA was about to hit the trees, MP pulled in as much collective as he could but described MA as "mushing through" or "didn't have enough power" in his efforts to stop the descent (Tab V-1.15). At some point during the maneuver, MP and MCP
