**UNITED STATES AIR FORCE**  
**AIRCRAFT ACCIDENT INVESTIGATION**  
**BOARD REPORT**

**HH-60G PAVEHAWK, T/N 92-26467**

**LOCATION: COPPER MOUNTAIN, LAKE CLARK, ALASKA**

**DATE OF ACCIDENT: 31 AUGUST 2014**

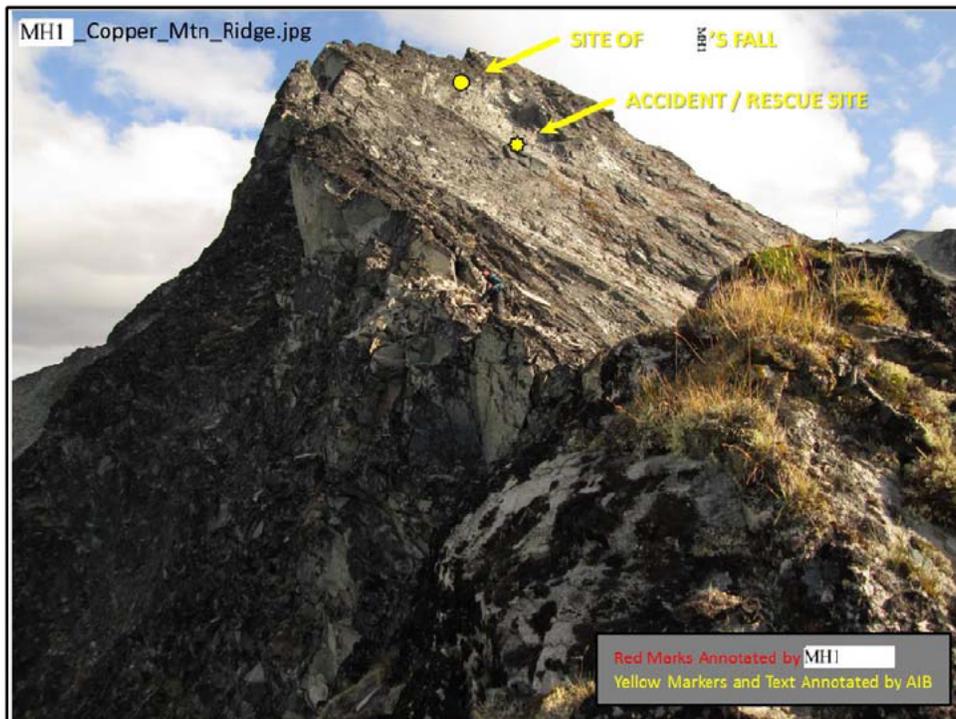
Figure 1 - Picture of Mishap Terrain (Tab Z-15)

V-4.2, and CC-26). Mishap Hiker 4 (MH4) described the rocks along the ridgeline as loose and crumbly and the hikers collectively described the rocks in the scree field below as loose, large, and sharp (Tabs V-1.5, V-2.6, V-3.6, and V-4.9). The hikers, and later the MC, assessed the steep angle to be 40-45 degrees of slope or steeper (Tabs V-1.8, V-2.6, V-14.7, and V-14.37). MH1 fractured his right wrist and suffered a severe laceration to his right forearm (Tabs V-1.3, V-3.3, V-3.8, and V-4.2). MH2, Mishap Hiker 3 (MH3), and MH4 made their way down to MH1's location and immediately began administering first aid (Tabs V-1.6, V-1.7, V-2.9, V-3.12, and V-4.4). At 1927L, MH2 contacted the NPS using a NPS radio to request helicopter rescue by hoist and professional medical attention because of the severity of MH1's injury and their inability to safely remove MH1, or for MH1 to remove himself, from the scree field and mountain (Tabs V-1.6, V-2.11, V-3.3, CC-25, and CC-26). The hikers maintained radio contact with the NPS ranger station at Port Alsworth throughout the rescue, with calls alternately made by MH2 and MH3 (Tabs V-1 through V-4, and CC-8 through CC-13).

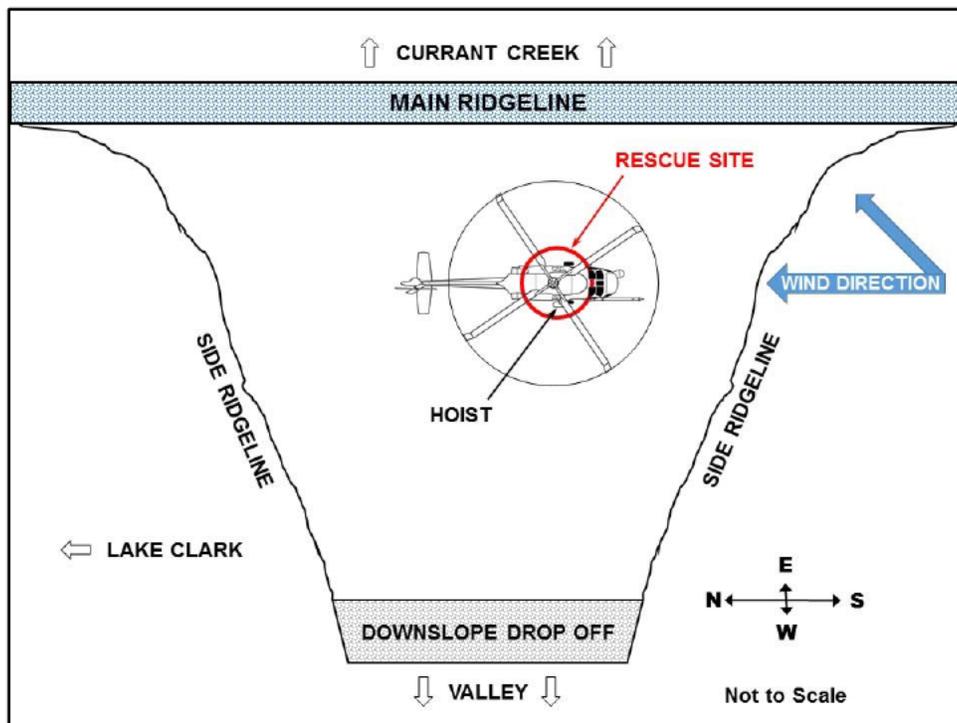
Figure 3 - Orientation of the MA Relative to the Rescue Site, Ridgeline, and Winds (Tabs V-10.7, V-10.8, V-10.14, V-10.15, V-11.7 through V-11.11, V-12.5 through V-12.10, V-13.15, V-14.6, V-14.37, and V-15.11)

After completing the offset hover, the MA executed an approach to the mishap site, approaching upwind from north to south with the left side of the MA parallel to and facing the ridgeline, to deliver the two PJs to the mishap site (Tabs V-10.8, V-10.16, and V-11.6 through V-11.12). Based on the MA orientation and estimated hoist height, along with the ground terrain and location of

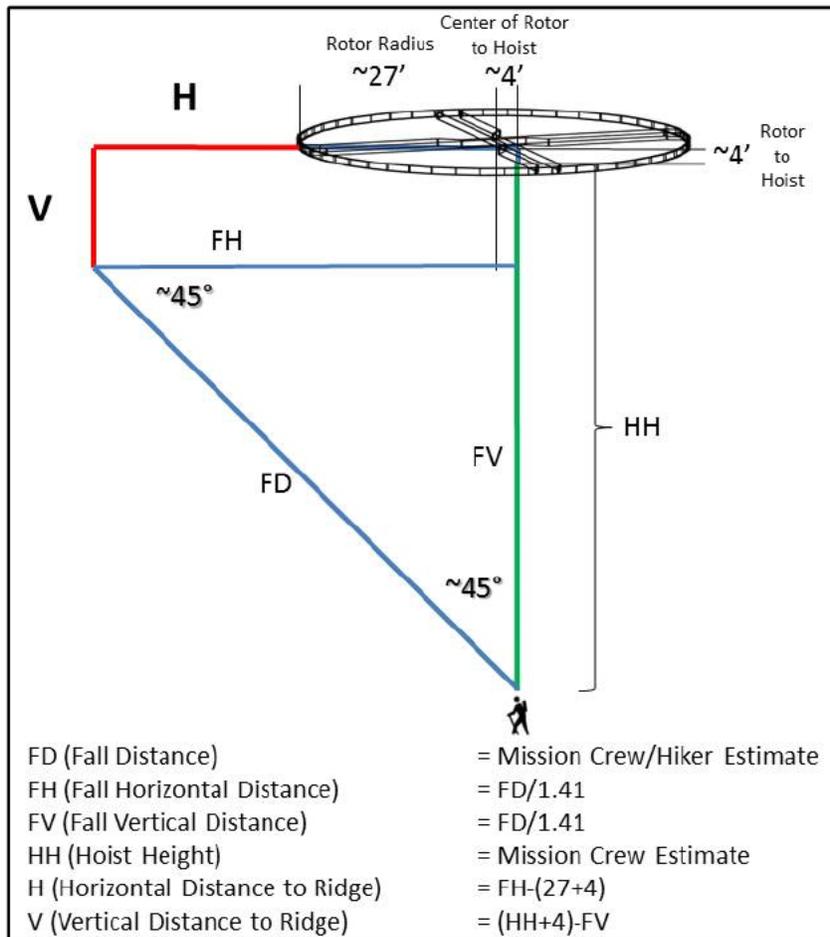
Fall Distance (feet)				Vertical Distance to Ridge (V) (feet)			Horizontal Distance to Ridge (H) (feet)
				Hoist Height (feet)			
	FD	FH	FV	60	80	100	
50	36	36	25	45	65	5	
75	53	53	<b>7</b>	<b>29</b>	47	<b>44</b>	
100	71	71	-11	10	30	69

the hikers relative to the ridgeline, the MA was estimated to only be about 44 ft horizontally away from and 7 ft to 29 ft vertically above the ridgeline (see Figure 4 above) (Tabs V-1.3, V-3.3, V-3.8, V-4.2, V-5.6, V-6.7, V-7.4, V-10.15, V-11.7 through V-11.9, V-12.6, V-14.12, V-14.37, V-15.5, V-15.8, V-19.11, and CC-26). While the MA was on approach and transitioning to a hover, rocks started falling (Tabs V-1.10, V-2.11, V-3.9, V-4.12, and CC-36). MH2 radioed the NPS that the hikers were being hit by rocks at 2305L (Tabs V-1.10, V-2.11, V-3.9, V-4.12, V-5.7, V-18.5, V-19.7, V-19.11, CC-36, and CC-39). In turn, NPS contacted the MSA at approximately 2307L, who relayed the situation to the MA (see Figure 5 below) (Tabs V-10.16, V-17.6, V-19.11, CC-12, CC-36, and CC-39). The MA left this first hover because of the rocks falling and did not insert their two PJs (Tab V-10.16). The MA transitioned from a hover to flying forward and circled near the mishap site (Tab V-10.16). At approximately 2309L, the MA requested the MSA inform the NPS to tell the hikers that the MA must hover over the mishap site to deploy their two PJs (Tabs V-19.7, V-19.11, and CC-12). At 2310L, the NPS notified the hikers of this plan and requested the hikers use their backpacks to protect themselves (Tabs V-2.11, V-3.3, V-5.8, CC-12, and CC-36). None of the hikers sustained significant injuries resulting from the rocks falling during this first hover (Tabs V-1.10, V-2.13, V-3.9, V-4.12, V-5.10, and CC-36).
