UNITED STATES AIR FORCE
AIRCRAFT ACCIDENT INVESTIGATION
BOARD REPORT

F-35A, T/N 19-5535

**355TH FIGHTER SQUADRON
354TH FIGHTER WING
EIELSON AIR FORCE BASE, ALASKA**

DATE OF ACCIDENT: 28 JANUARY 2025

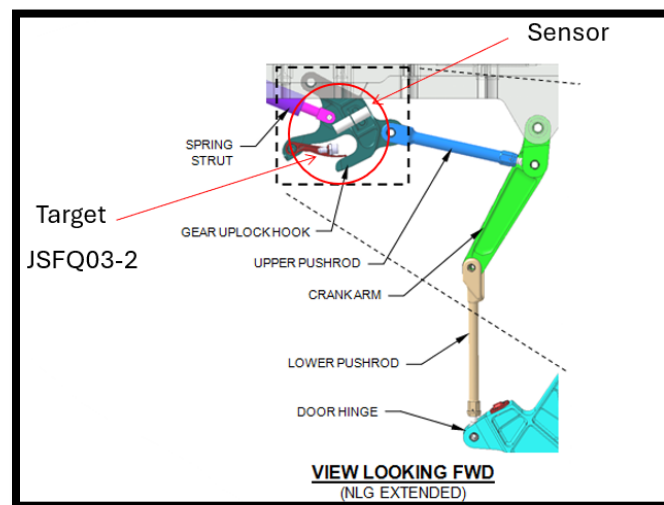
The landing gear system is a tricycle design consisting of the MLG and NLG, extension and retraction, wheels and brakes, nose wheel steering, position and warning, and arresting gear (Tab BB-199-200). The NLG Uplock Hook is used to ensure the NLG assembly is up and locked appropriately. The uplock is mechanically “slaved” to the NLG door (Tab J-176). The NLG is in the uplock so NLG door actuator will start to close the door, raising the uplock hook into the “LOCKED” position (Tab J-176). When the uplock hook is in “LOCKED” position, the doors are closed and aircraft is ready for full flight envelope (Tab BB-199-200).

Figure 10: NLG Uplock (Tab J-177)

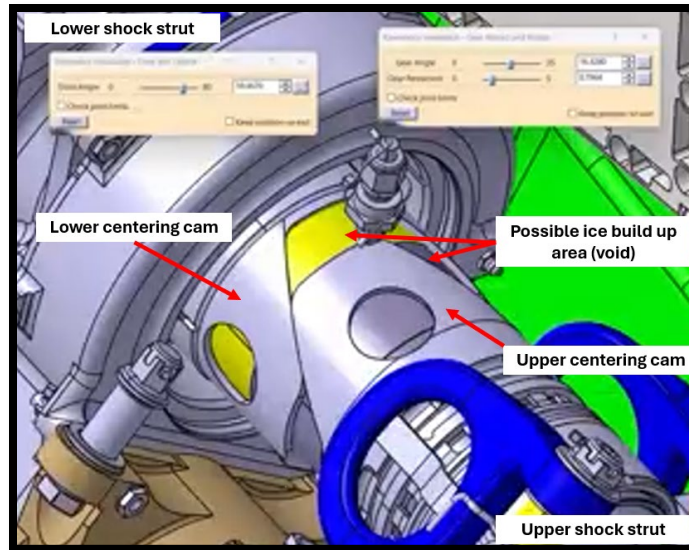
Figure 11: Nose Landing Gear Lower Shock Strut (Tab J-192)

Additionally, significant pitting was identified within the LG piston that, while caused by contamination to the hydraulic fluid, did not affect the LG function (Tab BB-255).

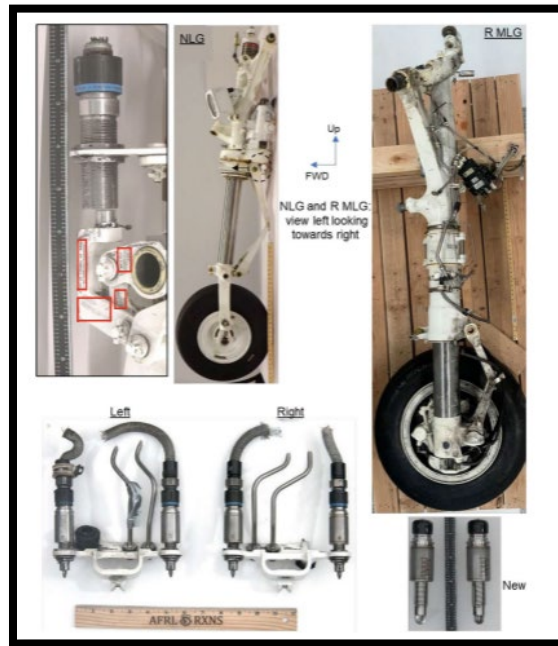
Figure 13: NLG, MLG, and WoW Sensors (Tab J-22)

After the NLG uplock hook missed the roller, the NLG was forced left 17.5 degrees (Tab J-191). Leading to the IFE and multiple touch-and-go attempts (Tab J-91). After the first touch-and-go, the RMLG and NLG WoW sensors showed weight on wheels despite the MA being airborne (Tab J-91). This was because aforementioned ice buildup prevented the NLG and RMLG struts from fully extending or retracting (Tab J-185). On the last touch-and-go, the NLG wheel went from 17.5 degrees to 6 degrees after it was allowed to briefly touch the runway (Tab J-186).

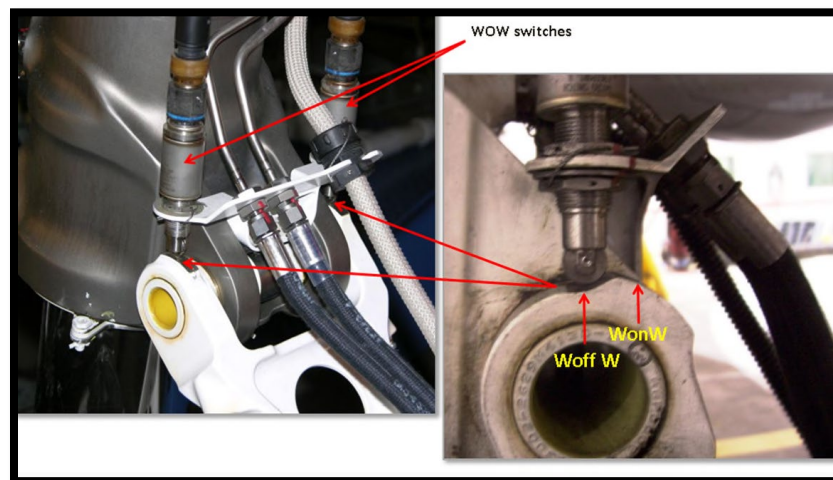
The WoW sensors are one component of the F-35A's flight control system (Tab J-127). Each MLG has two WoW sensors that are mounted on the shock strut (Tab J-129). These sensors, along with a single WoW in the NLG, are part of a redundant system that is intended to function even when multiple WoW sensors fail (Tab J-129). When the shock struts are fully extended and then compressed by the weight of an aircraft, the WoW sensors are designed to reflect that the aircraft is on the ground (Tab BB-199-200). Both main gear WoW sensors are plunger-type sensors actuated by keeping physical contact with the landing gear torque arms integral cam (Tab J-129).

Figure 15: WoW MLG Sensors (Tab J-180)

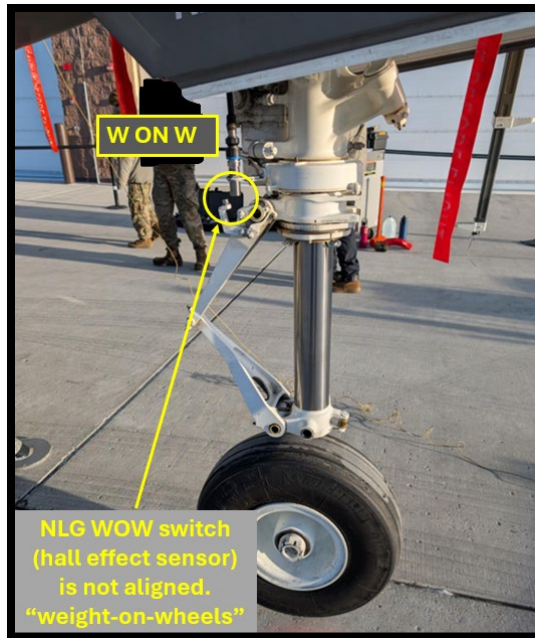
Figure 16: NLG WoW Sensors (Tab J-180)

The NLG WoW switch is a hall-effect sensor actuated by the upper torque arm (Tab J-179). The magnet side of the sensor must be within a pre-determined distance from the sensor for the aircraft to recognize weight OFF wheels (Tab J-179).
