**UNITED STATES AIR FORCE**  
**GROUND ACCIDENT INVESTIGATION**  
**BOARD REPORT**

**TYPE OF ACCIDENT: On-Duty Fatality**

**LOCATION: Joint Base Pearl Harbor-Hickam, Hawaii**

**DATE OF ACCIDENT: 8 January 2013**

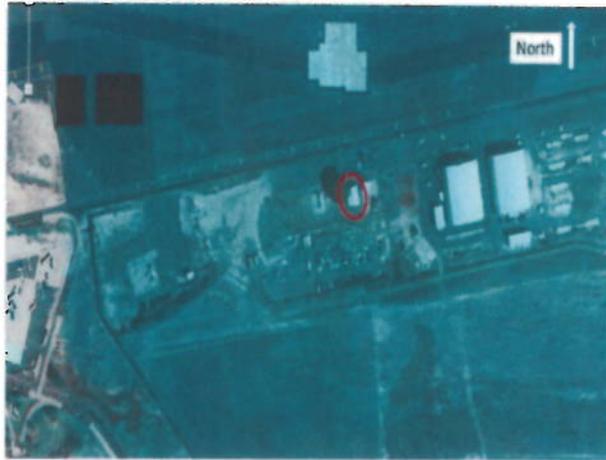
Figure 4: (Tab Y-2)

(1) Building 3245 is located on Kamikahi Road, JBPH-H, HI, on the west end of the Honolulu International Airport (Tab Y-1, Tab Y-2, Fig. 4). The building was constructed in January 1966 (Tab U-2.1). It is a Transient Alert warehouse used for storing visiting personnel equipment (Tab V-15.1).

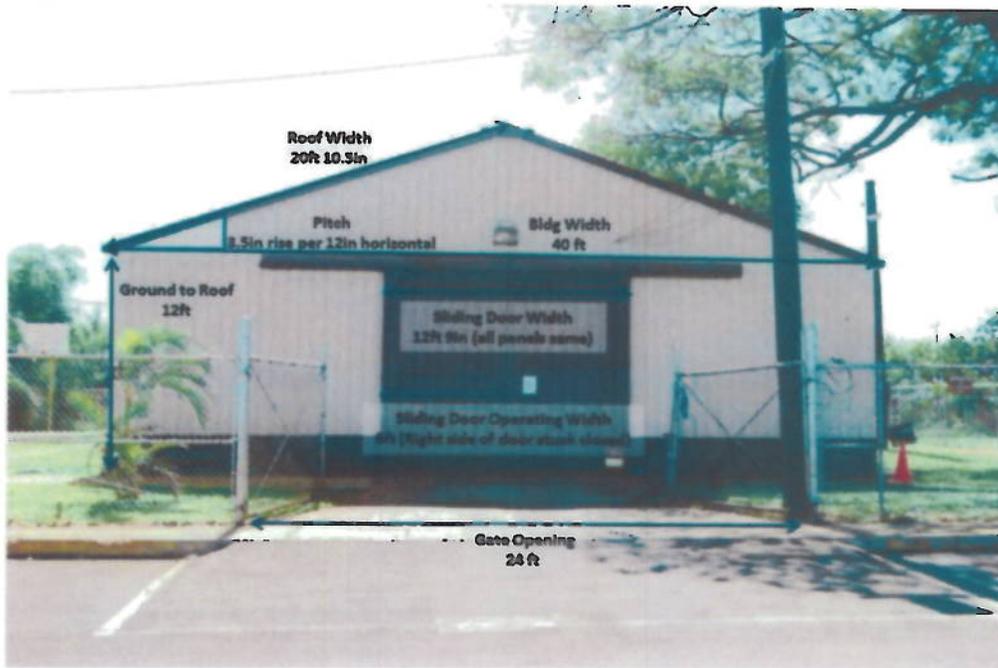
Figure 5 (Tab Y-3)

(2) Plans and building construction information for Building 3245 were unavailable, however, the Board conducted a survey of the building (Tab BB-5.1). Building 3245 is a single story building with a sloped gable roof (Tab BB-5.1, Tab Y-3, Tab Y-4). The building has main-entry sliding doors constructed of steel frame tubing and ribbed metal sheeting (Tab BB-5.1, Tab Y-3, Fig. 5). The current sliding door operating width was only six feet due to the right door stuck in a closed position (Tab BB-5.1, Tab Y-3). The building consists of metal frame construction on a concrete slab on grade (Tab BB-5.1, Tab Y-3). The roof is sloped at a 3.5 inches (in):12in ratio pitch (3.5in rise for 12in run) (Tab BB-5.1, Tab Y-3, Fig.5). The wall height on both sides of the building is 12ft (Tab Y-4, Fig.6). The highest point from floor to ridge is 18ft 6in (Tab BB-5.1, Tab Y-4, Fig. 6). The building is open beam construction and has no false ceiling (Tab Y-23, Fig.7). The building contains steel frame shelving units with plywood shelves (Tab Y-23, Fig.7).
